UTM CAPITAL PROJECTS: Status Report - Level 1

UTM Campus Affairs Committee
May 12, 2022

Level 1 Projects

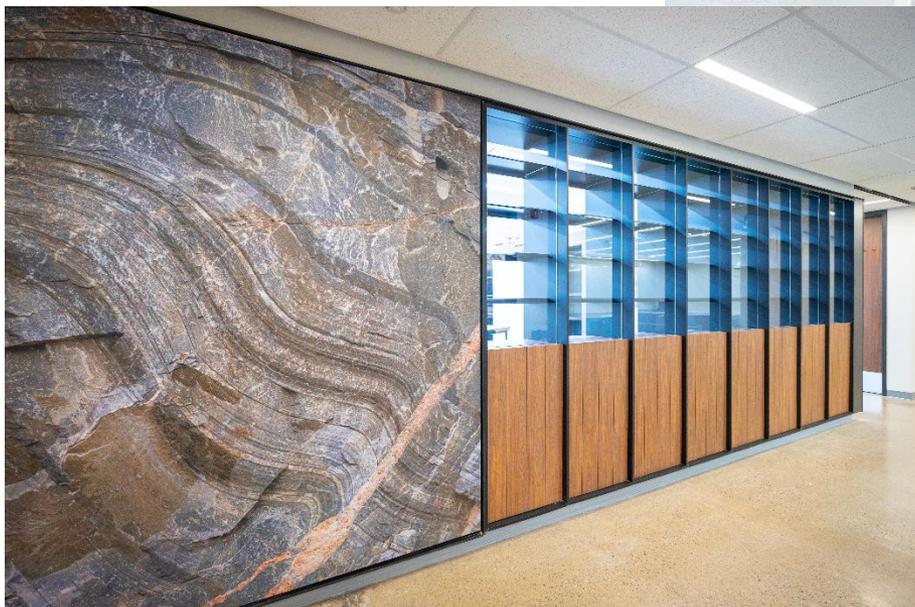
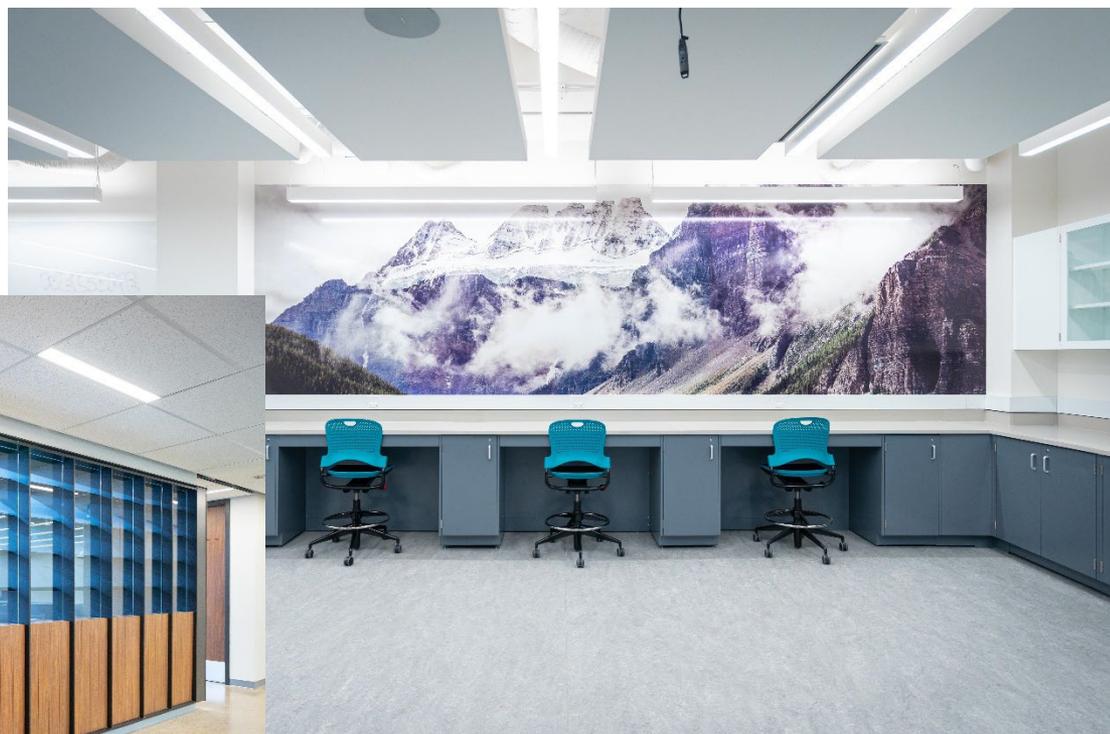
Geography/Earth Sciences Lab renovation

- Teaching lab and program space created in Davis Level 1
- Significant delays and water infiltration

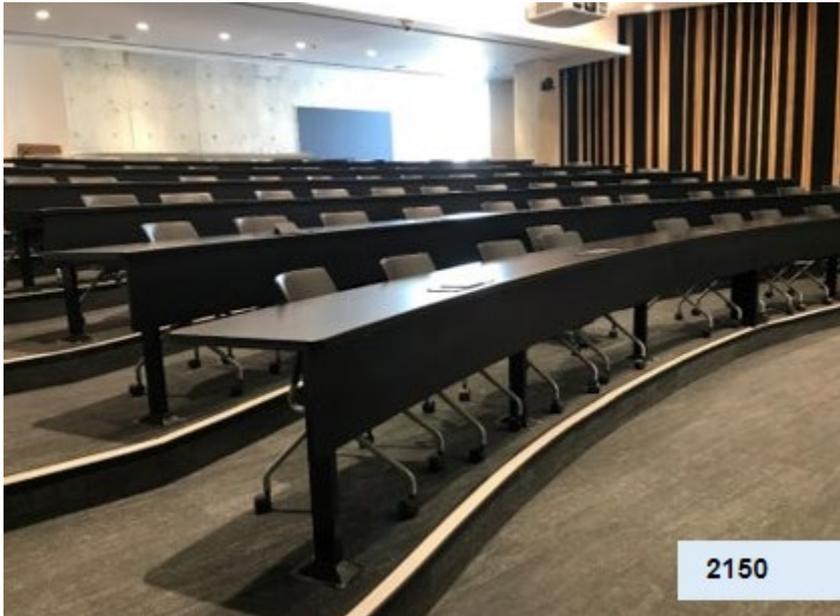
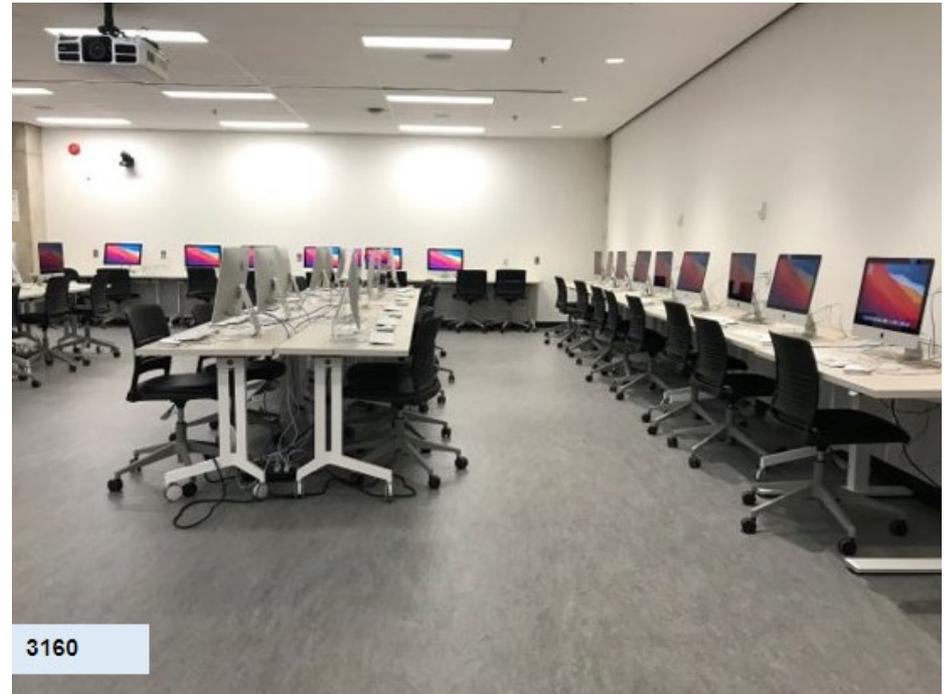
CCT Classroom Updates – CCT 2140, 2150, 2160, 3160

- Refreshed computer labs and lecture theatres
- New flooring, AV/tech, tables and seating

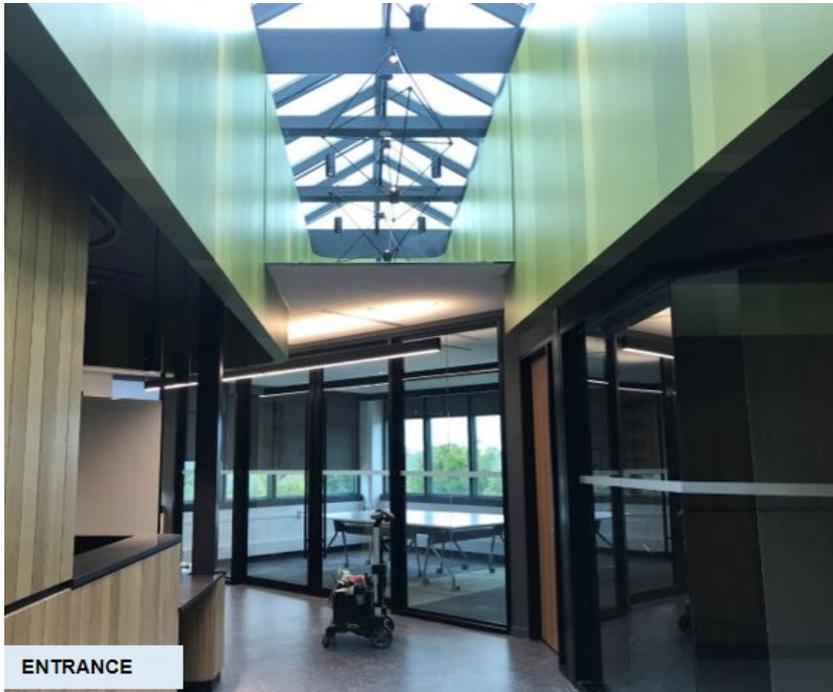
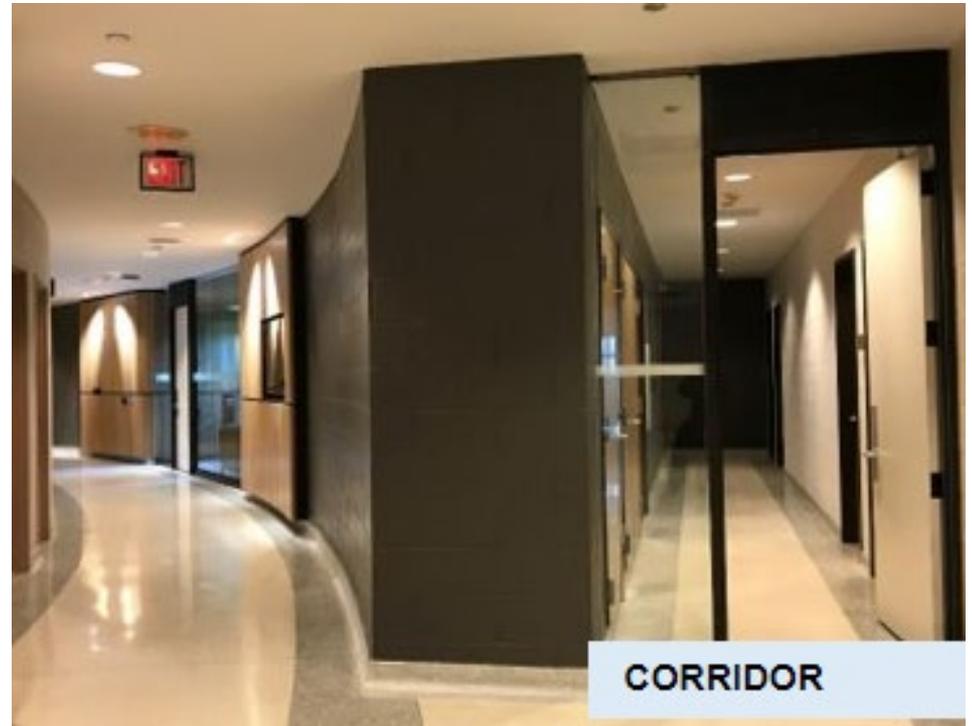
Kaneff Centre Management/IT Upgrades

- Bright open office space created w/kitchenette on level 2
- Densified to create space for more staff/programs
- Corridor revamp, IT Room upgrade

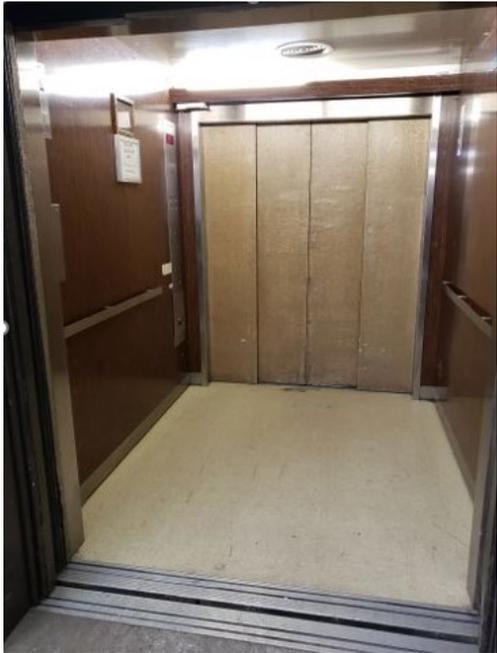
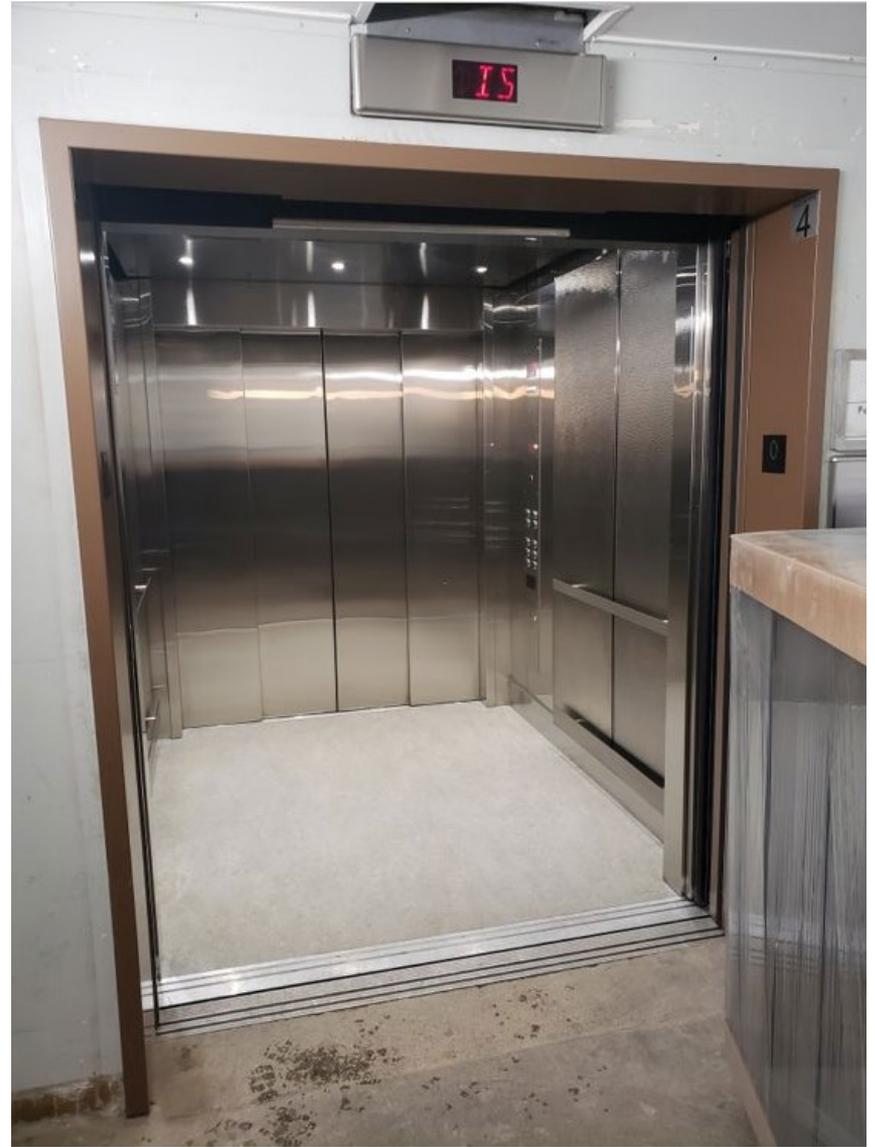
Elevator Modernization

- Cabs 1, 2 & 4 in the Davis Wing
- Original to the Davis Building circa 1970
- Better control systems
- More efficient call times, shorter wait time

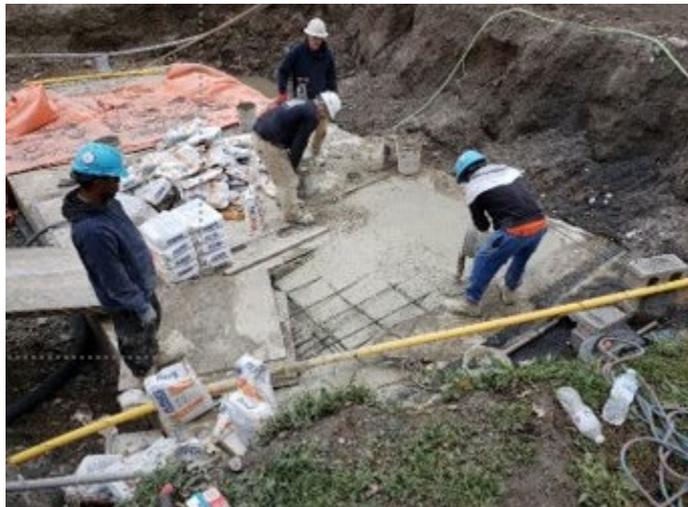
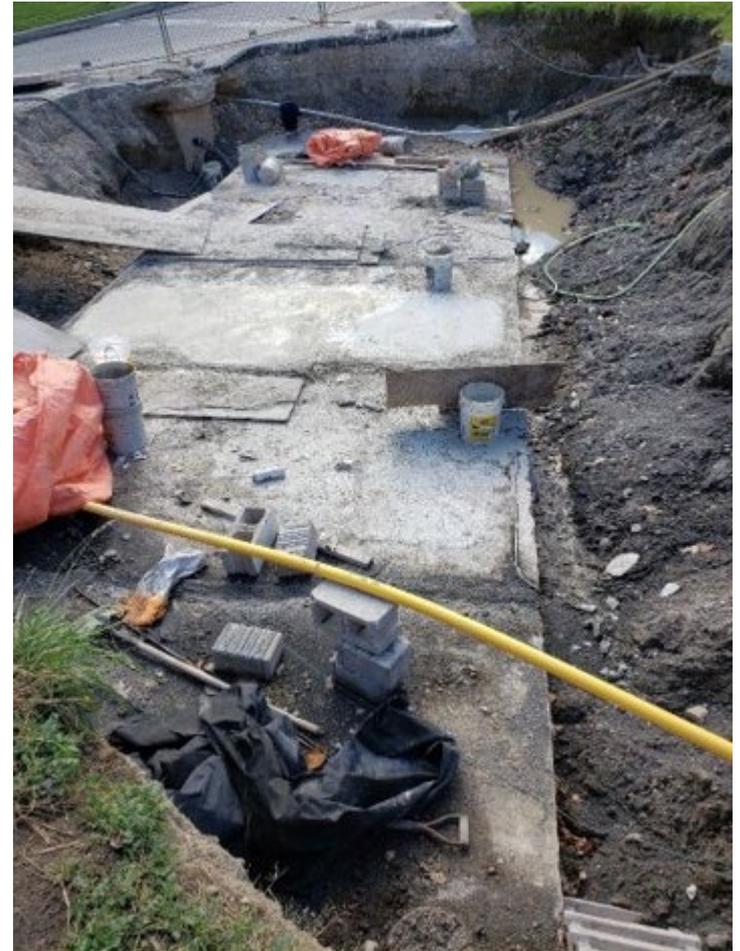
CUP Tunnel Repair

- Decades of salt and water runoff from Outer Circle Road had damaged the Utility Tunnel beneath
- Excavated road, chipped and re-poured tunnel structure
- Significant traffic interruption, completed before return to campus

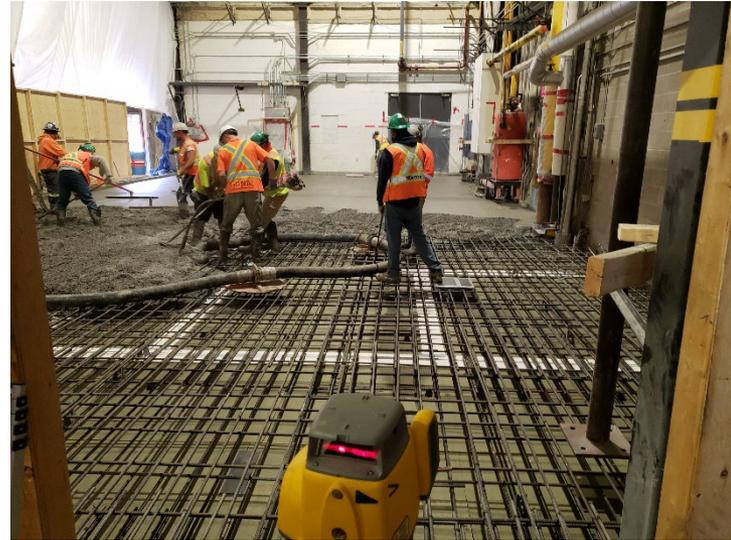
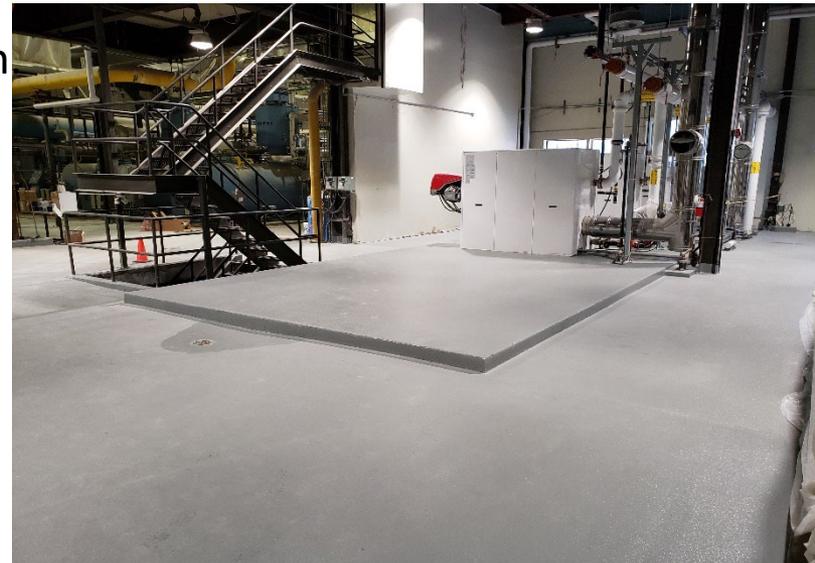
CUP Slab Rehabilitation Project

- CUP was built in 1960's
- Slab is cracking in multiple areas and water penetration has exposed rebar.
- Structural assessment has Indicated widespread corrosion related to deterioration
- Testing has revealed that a full slab and structural beam replacement is necessary to prevent structural failure.

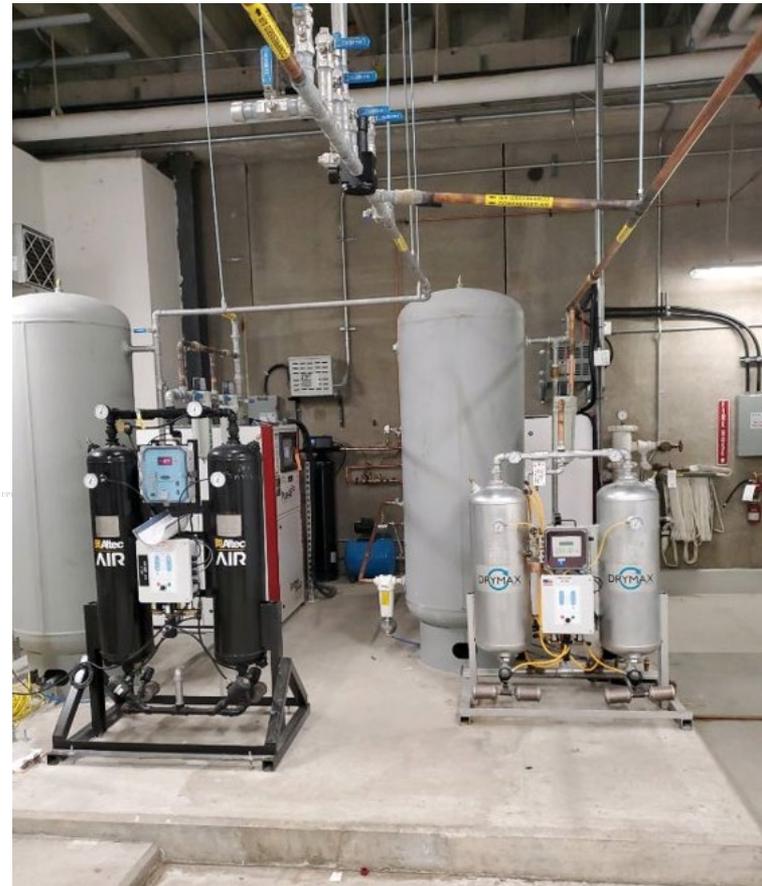
Davis CABB Air Compressor Replacement

- The Davis CABB Air compressor systems serves CABB building and several areas in D Block. It had reached end of life,
- New system supports increased capacity, redundant compressors (more reliable) and air quality.

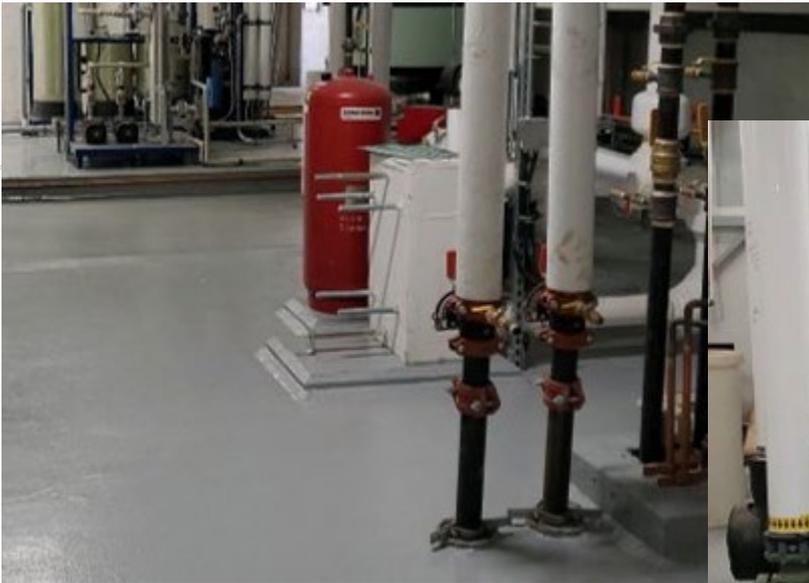
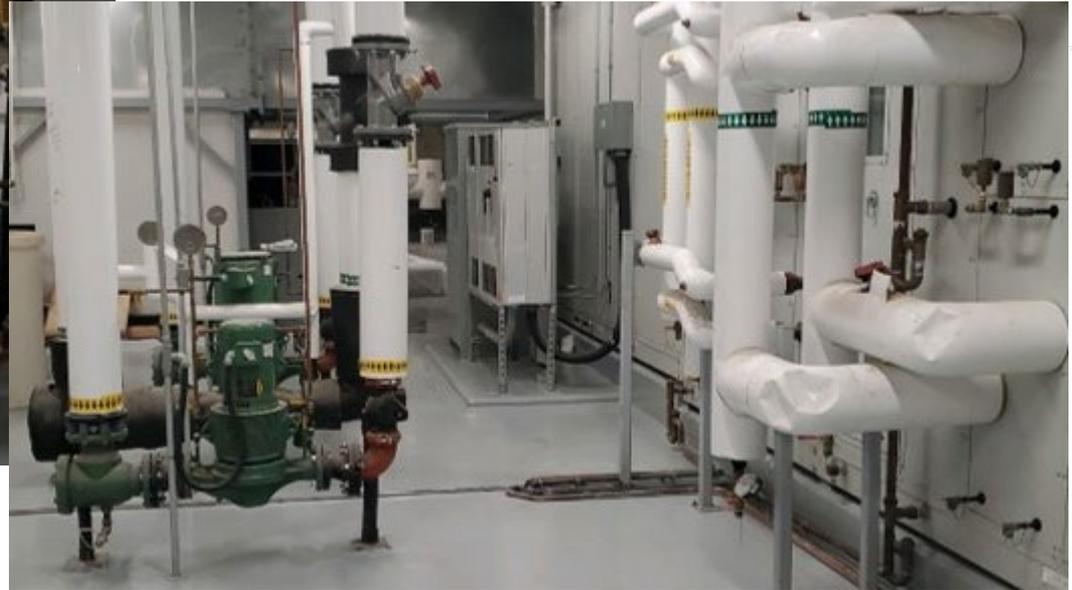
Davis D Block Mechanical Slab Remediation

- Slab remediated to mitigate water/glycol leaks seeping from penthouse mechanical room
- Remediated 9000sq ft of flooring, installing waterproofing
